Manhole Inspection Summary

Manhole # S49GG_053MH

Insp Date: **8/8/08 10:23 AM**

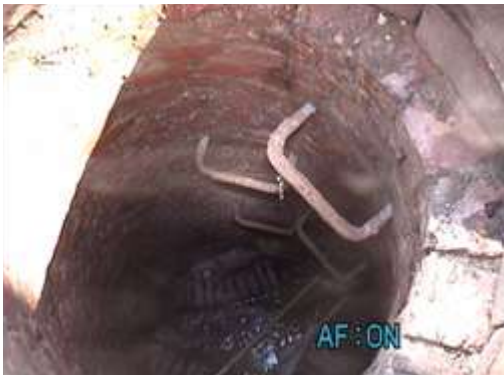
Defect 2

Infiltration: ☐ None ☐ Joint ☐ Cracks ☒ **Mortar** ☐ Roots ☐ Wall

Infiltration: ☐ None ☐ Joint ☐ Cracks ☐ Mortar ☐ Roots ☒ **Wall**

Infiltration

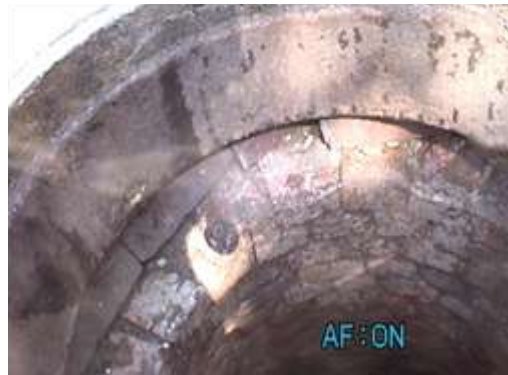
Defect 1

frame leaks

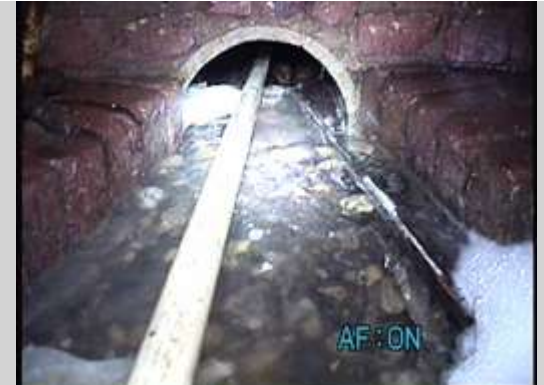
12 O'Clock Outflow

8 in. Circular Gravity Sewer
Pipe Out @ 12 O'Clock

Pipe Height: **8.4** (in.) Rod and Bar (Angled)
Pipe Material: **Clay** ☐ Pipe Lined
Invert Depth: **11.30** (ft.) Flow Characteristics: **Slow**
Deposits: ☐ None ☐ Mud ☐ Sludge ☒ **Debris** ☐ Grease
Silt Depth: **0** (in.) Deposits Extent: **Light**
Infiltration: **None** Pipe Seal Cond: **Sound**

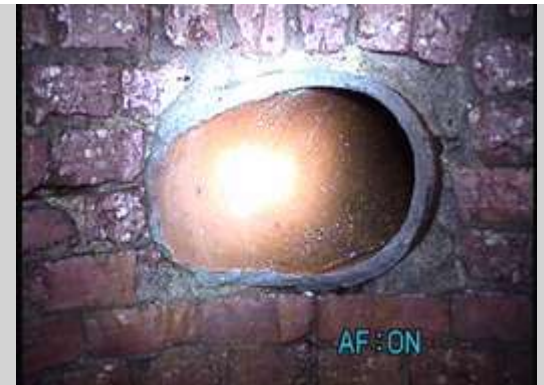
6 O'Clock Inflow

8 in. Circular Gravity Sewer
Pipe In @ 6 O'Clock

Pipe Height: **8.4** (in.) Rod and Bar (Angled)
Pipe Material: **Clay** ☐ Pipe Lined
Invert Depth: **8.35** (ft.) Flow Characteristics: **Slow**
Deposits: ☒ **None** ☐ Mud ☐ Sludge ☐ Debris ☐ Grease
Silt Depth: (in.) Deposits Extent:
Infiltration: **None** Pipe Seal Cond: **Sound**

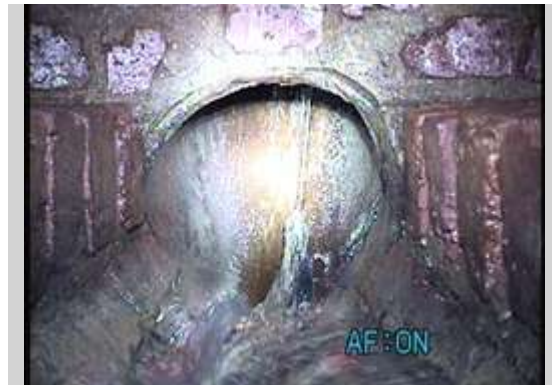
Drop In @ 6 O'Clock

Drop: **Outside** Rod and Bar
Angled: **Yes** Reading: **10.20** (ft.)
Inv Depth: **11.20** (ft.)

Drop Condition: **Open**

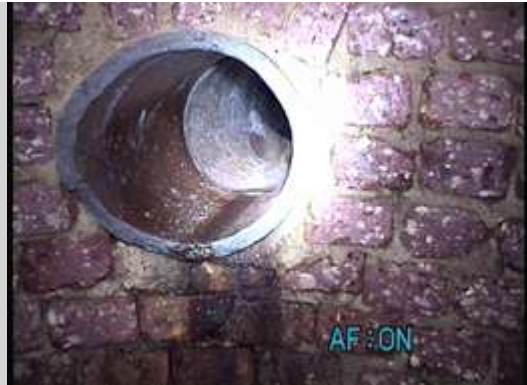
9 O'Clock Inflow

Pipe In @ 9 O'Clock

Pipe Height: **8.4** (in.) Rod and Bar (Angled)

Pipe Material: **Clay** ☐ Pipe Lined

Invert Depth: **8.05** (ft.) Flow Characteristics: **Slow**

Deposits: ☒ None ☐ Mud ☐ Sludge ☐ Debris ☐ Grease

Infiltration: **None** Pipe Seal Cond: **Sound**

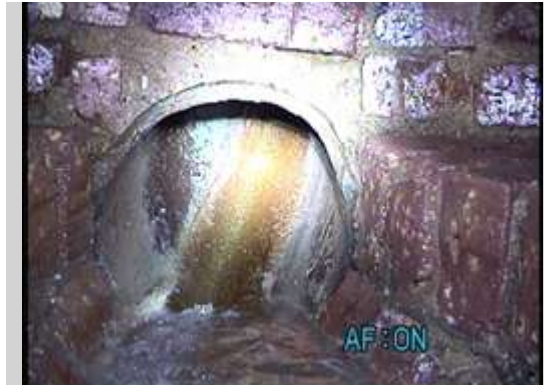
Drop In @ 9 O'Clock

Drop: Inside	Rod and Bar
Angled: Yes	Reading: 10.15 (ft.)
	Inv Depth: 11.15 (ft.)
Drop Condition: Open
